American Aircraft Appraisal and Export
AIRCRAFT APPRAISAL REPORT

Make: CESSNA AIRCRAFT COMPANY **Model:** COLUMBIA 350

Serial No: 42062 **Reg. No.:** N350SF **Yr. Mfg.:** 2004

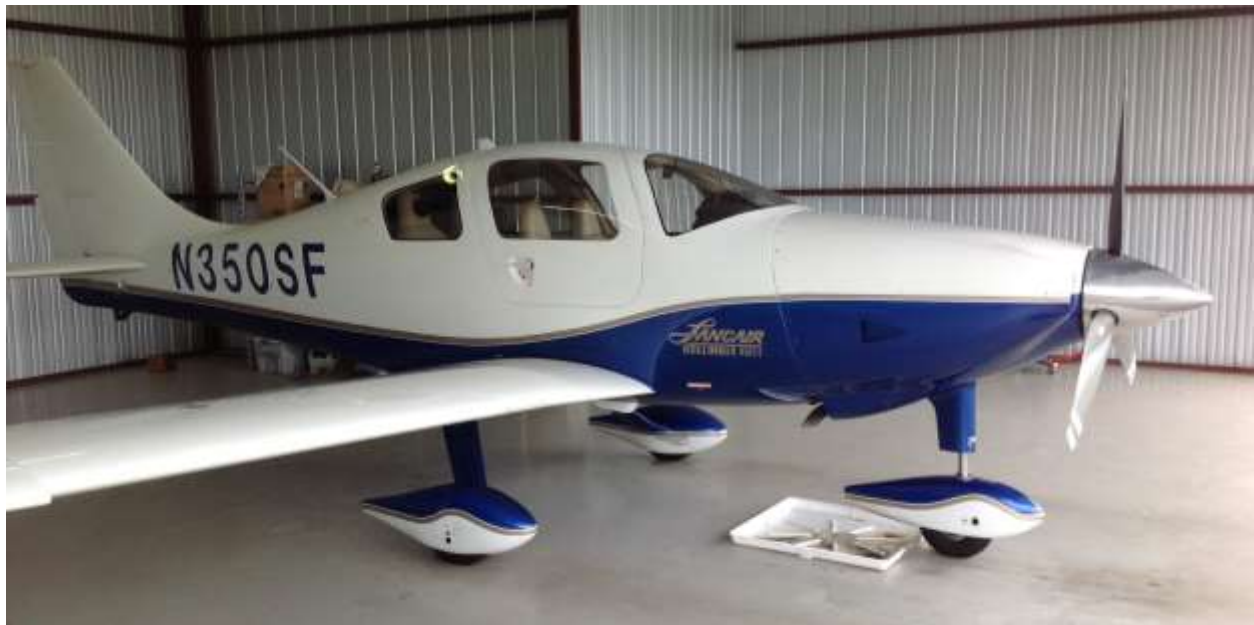
Airframe Condition: Very Good

Comments on Visual Inspection: The exterior paint has a consistent gloss finish, with minimal light scratches throughout the entire airframe. No delamination of the composite airframe was noted. There is minor chipping of the airframe composite finish around the upper edges of the windshield. Leading edge tape is installed on the wings and empennage. Windshield and all glass throughout the cabin are very clear, with few minor scratches and blemishes. The window fit is good, though the door fit is not flush with the outer cabin skins all around. The main doors each have a minor tear in the weather stripping, which were professionally repaired. A small crack on the nose wheel fairing, and the main wheel fairing were noted, each less than one inch in length, likely due to normal wear and tear from routine maintenance of the wheels and accessories. These discrepancies noted above are simply cosmetic issues, as reported by a local Airplane Inspector. There are no other signs of current or previous damage, and the NTSB record is clear. The wing walk area non-skid is in good condition. All three tires show minimal wear. The landing light lens cover is slightly obscured. Aircraft belly has a light film of oil and dirt, normal for an airplane that flies regularly, as this Cessna appears to.

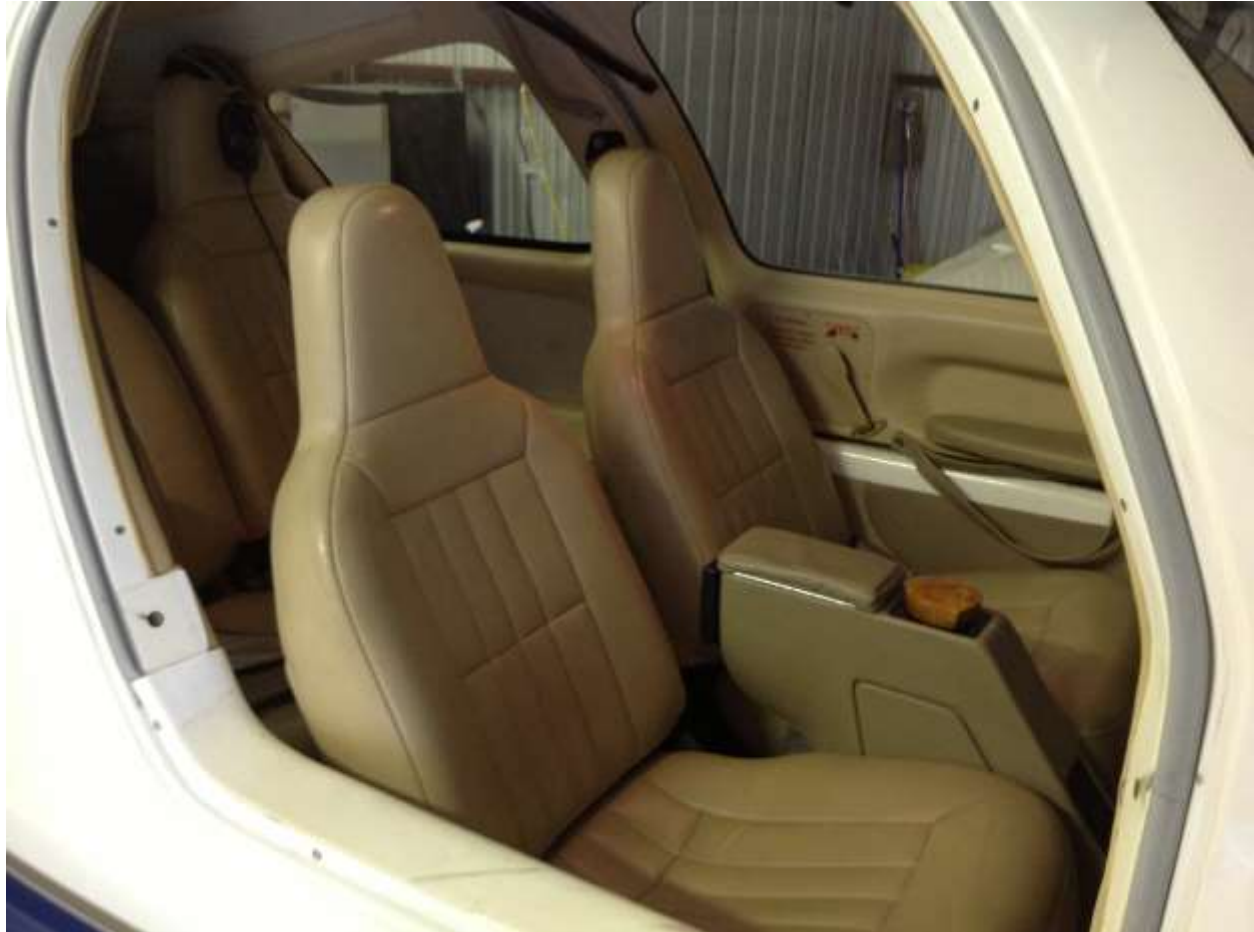
Interior Comments: The interior appears to be factory original. All seats, door panels, and most of the interior trim are finished with a light tan leather. The forward lower cabin walls are covered with a taupe color leather. Door panels and headliner have a linen color cloth insert. Leather seats show some wear-light checking of the leather in some areas. There is average wear noted on the other interior surfaces, including the carpeting. No tears or stains were found. Finished wood side stick flight control handles and the fuel tank selector handle are in very good condition. Seatbelts show light discoloration due to normal use over time. The door threshold protective film tape has scuff marks. Overall, the interior is clean and very pleasing.

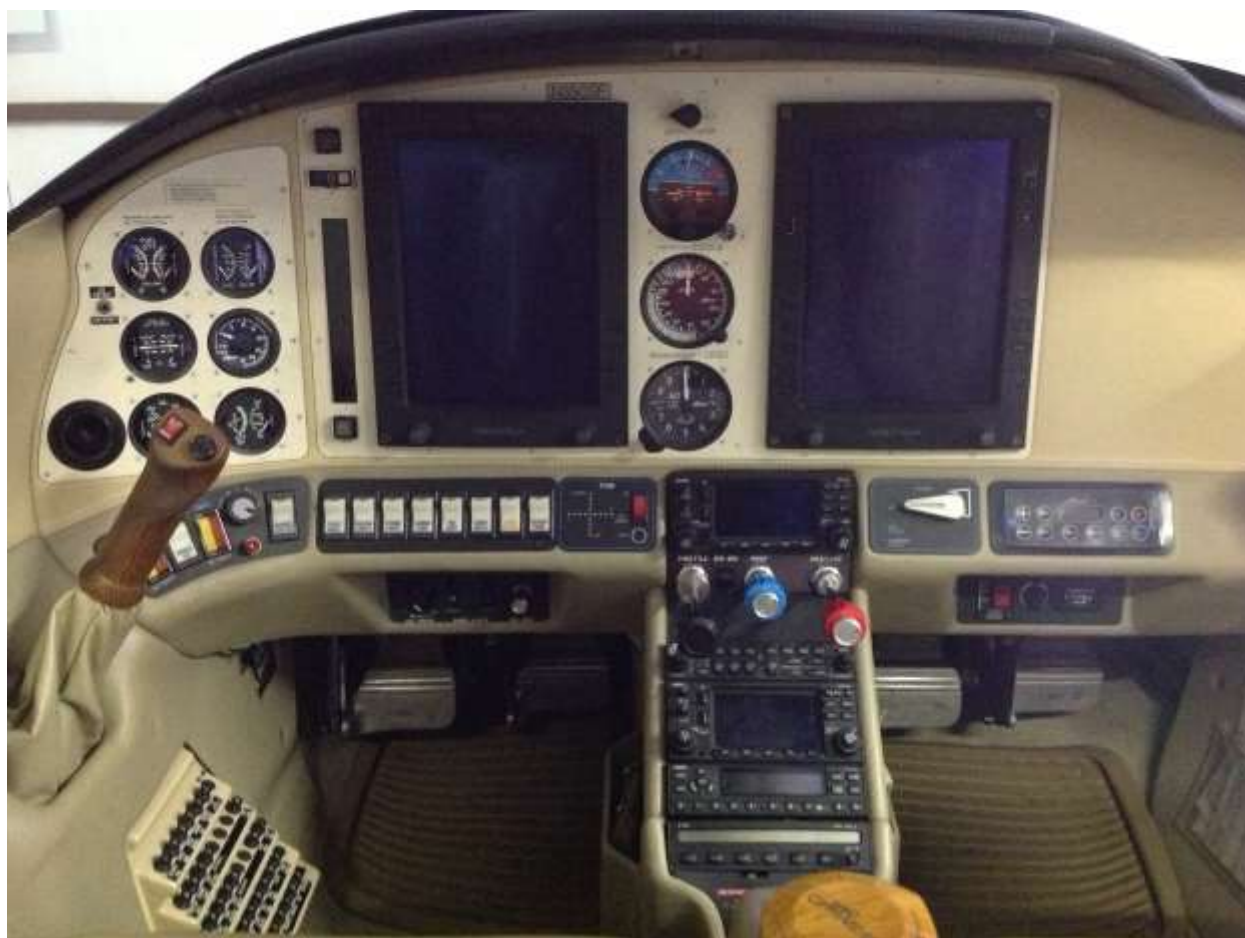
Comments: The instrument panel is very clean and the gauges are easy to read. There are some smears on the multi-function display (MFD) and the primary flight display (PFD), likely from finger prints. All installations appear to be factory specification.
